BLM Cedar City Field Office Site Inspection Report

File: UTU-80852; Blawn Mountain Kaolin Mine Project
Sandy Nell / Lone Star Mining

Inspector: Ed Ginouves, CCFO Mining Engineer

Insp. Date: Sept. 30, 2011

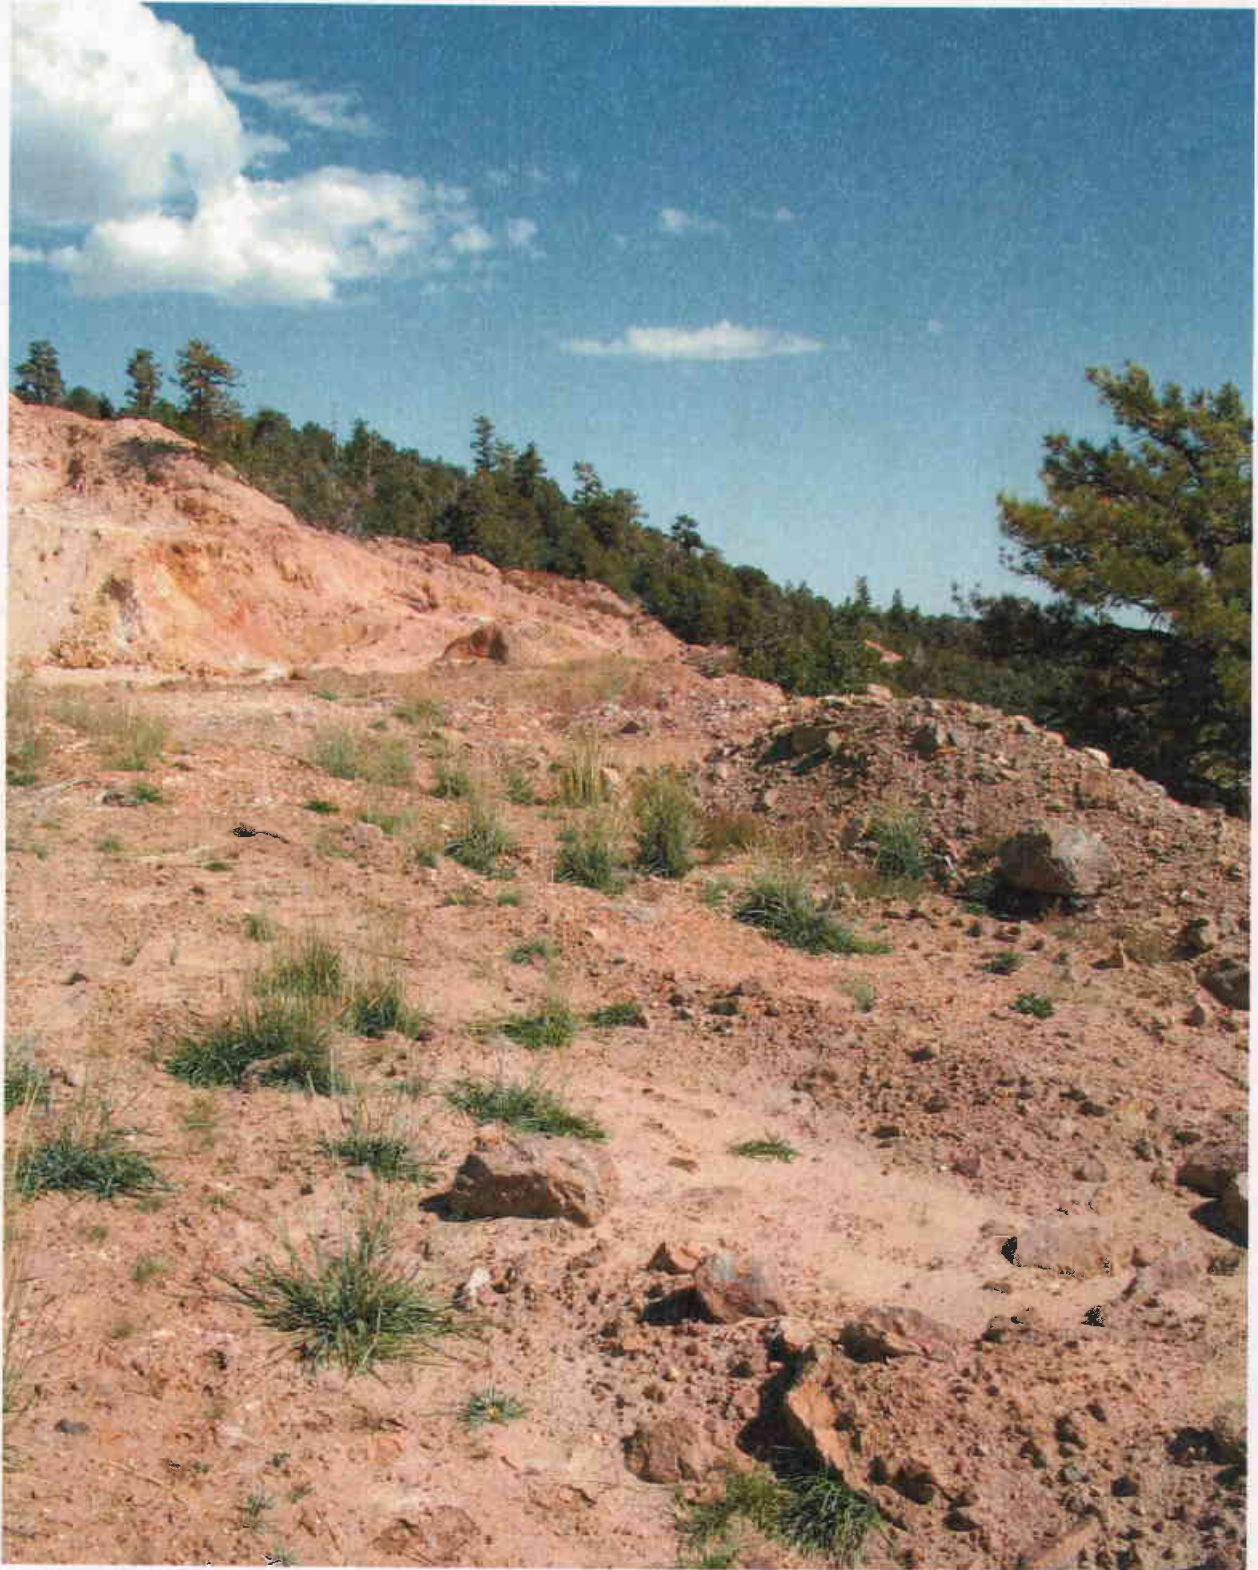
UTU-80852: Blawn Mtn Kaolin
Sept. 30, 2011

The mine site remains inactive. There was evidence that at least one sample hole had been drilled in the pit bottom very recently. The drilling had been done with a track-mounted drill and the hole had been backfilled. Overall, the vegetative cover continues to improve on the two acre area that had been reclaimed and seeded two years ago at the southern end of the site. Only a small portion (~1/4) of the reclaimed area could be considered to be fully successful, that being the area that received the lion's share of the salvaged topsoil.

Vegetative cover typical of topsoiled areas on portions of mine site reclaimed in Nov. 2009

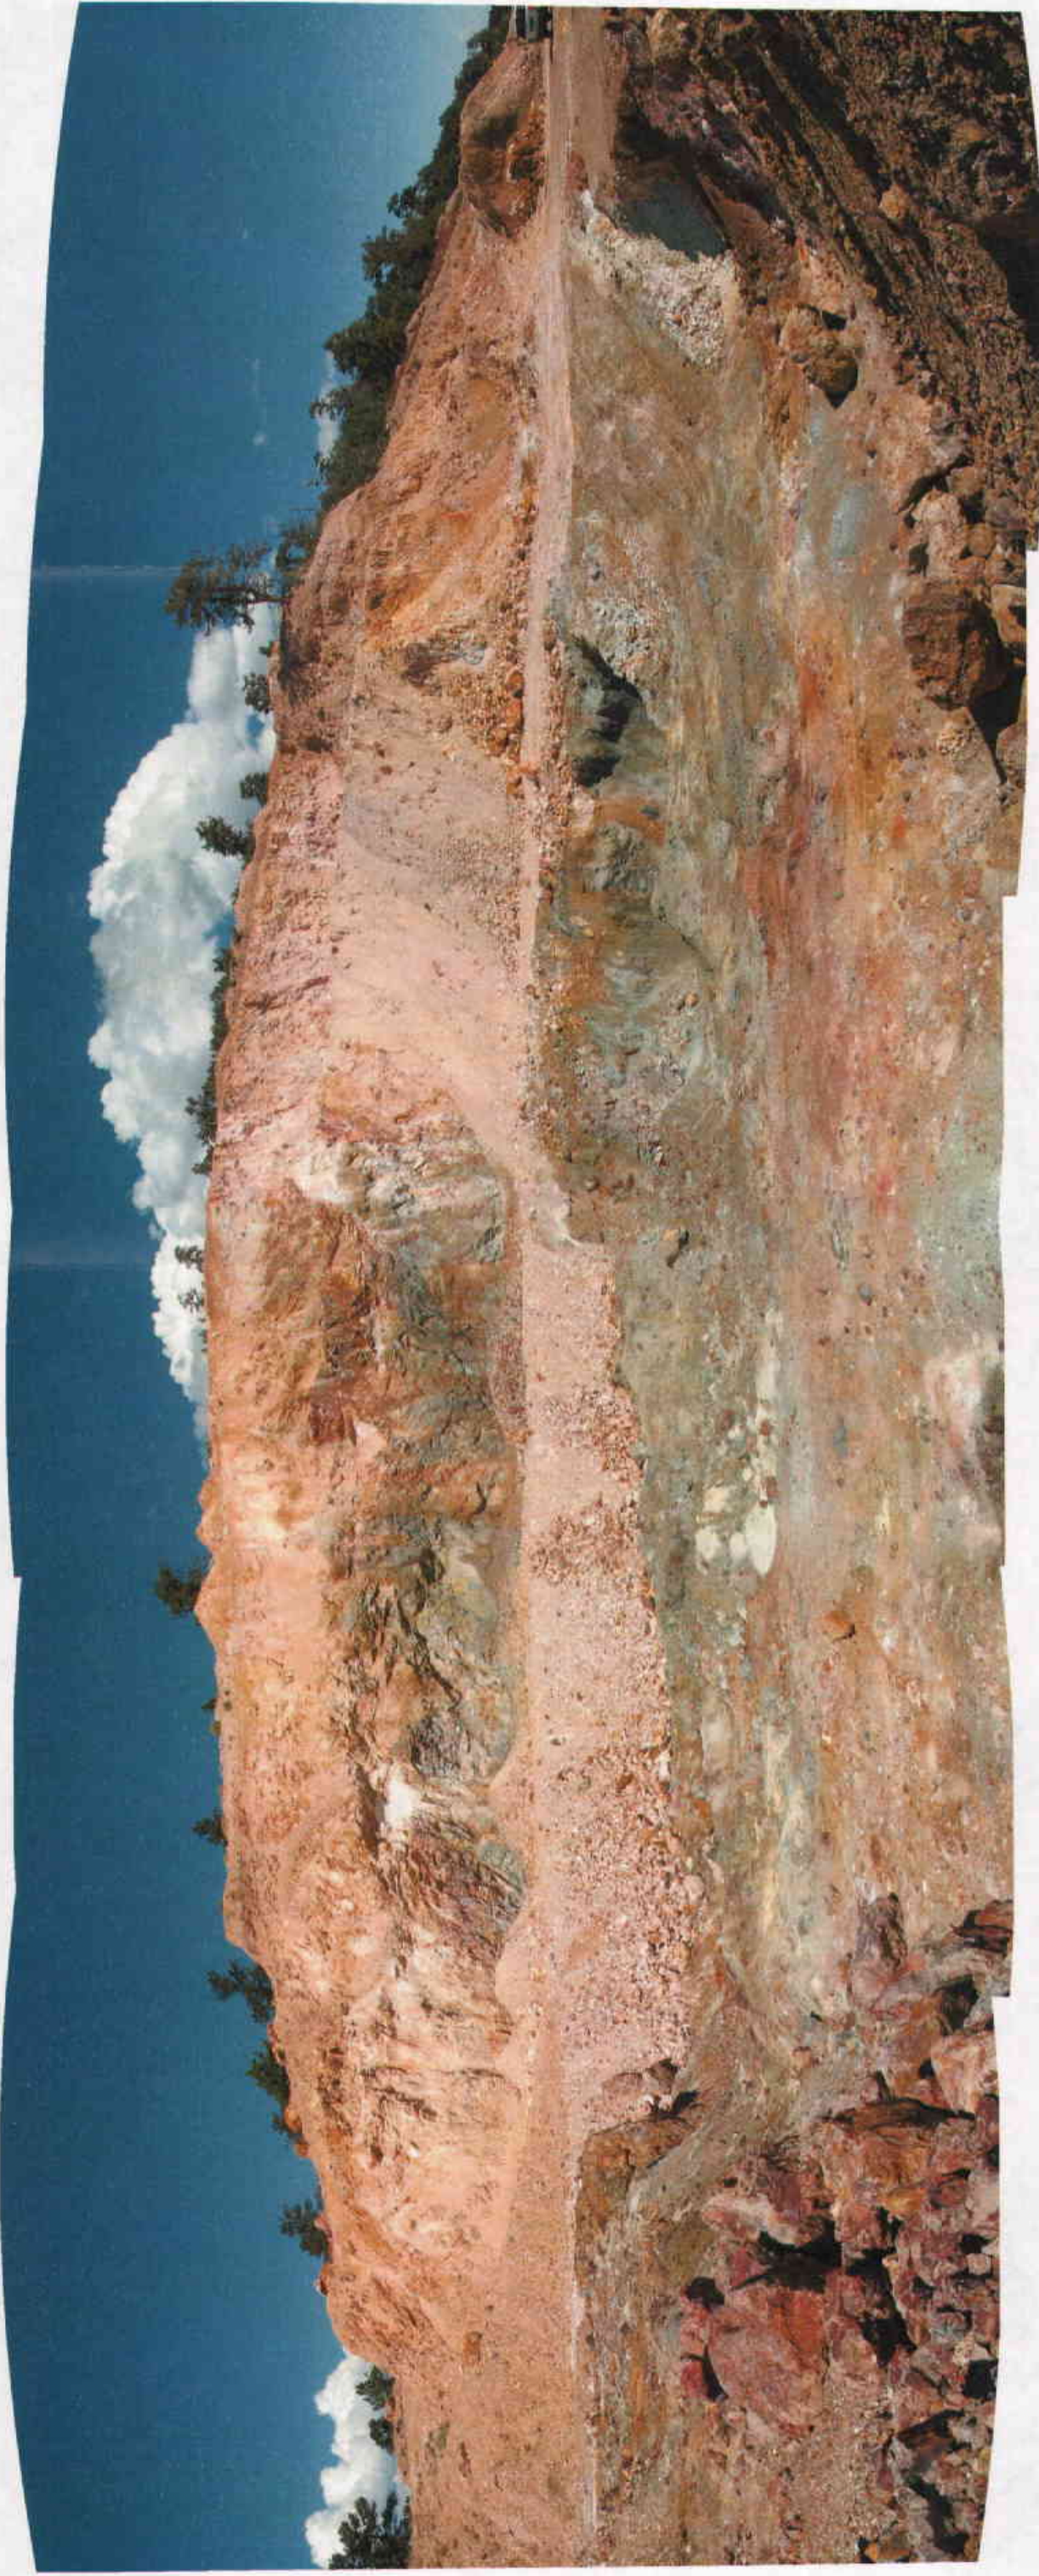
UTU-80852: Blawn Mtn Kaolin
Sept. 30, 2011

View looking north at idled pit area.
